## Monthly Dust Monitoring Report

L STREET STATION PROJECT  
*Boston, Massachusetts*

Prepared for HRP 776 Summer Street PropCo, LLC  
File No. 4867.03  
July 2023

### JULY 2023

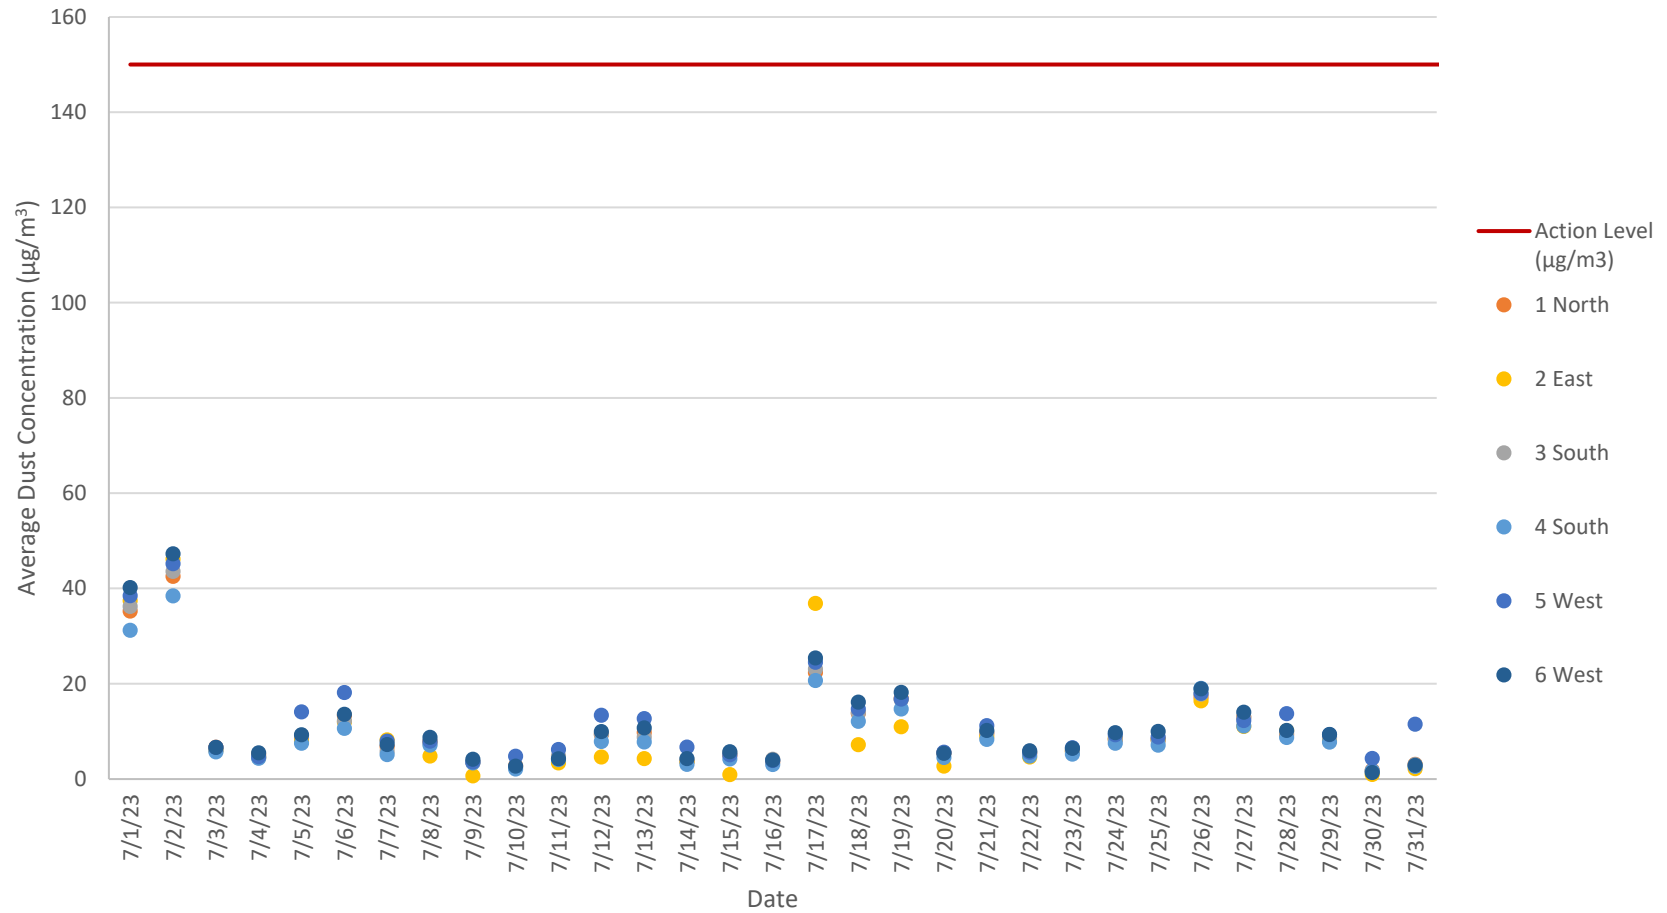
**Dust Concentration 24-hour Averages**  
**July 1 - July 31, 2023**  
 776 Summer Street  
 Boston, Massachusetts

Dust data was collected in accordance with the site perimeter DMP, and the results for July 2023 are included on Figure 3. As shown on the figure, there were no exceedances of the dust action level of 150 µg/m<sup>3</sup> for PM10 particulates based on a 24-hr average.

No corrective measures were required for dust mitigation in June 2023 because dust concentrations collected were well below the calculated Site-specific action level.
