MONTHLY DUST MONITORING REPORT

L Street Station Project
Boston, Massachusetts

Prepared for: HRP 776 Summer Street, LLC
File No. 4867.03
May 2022

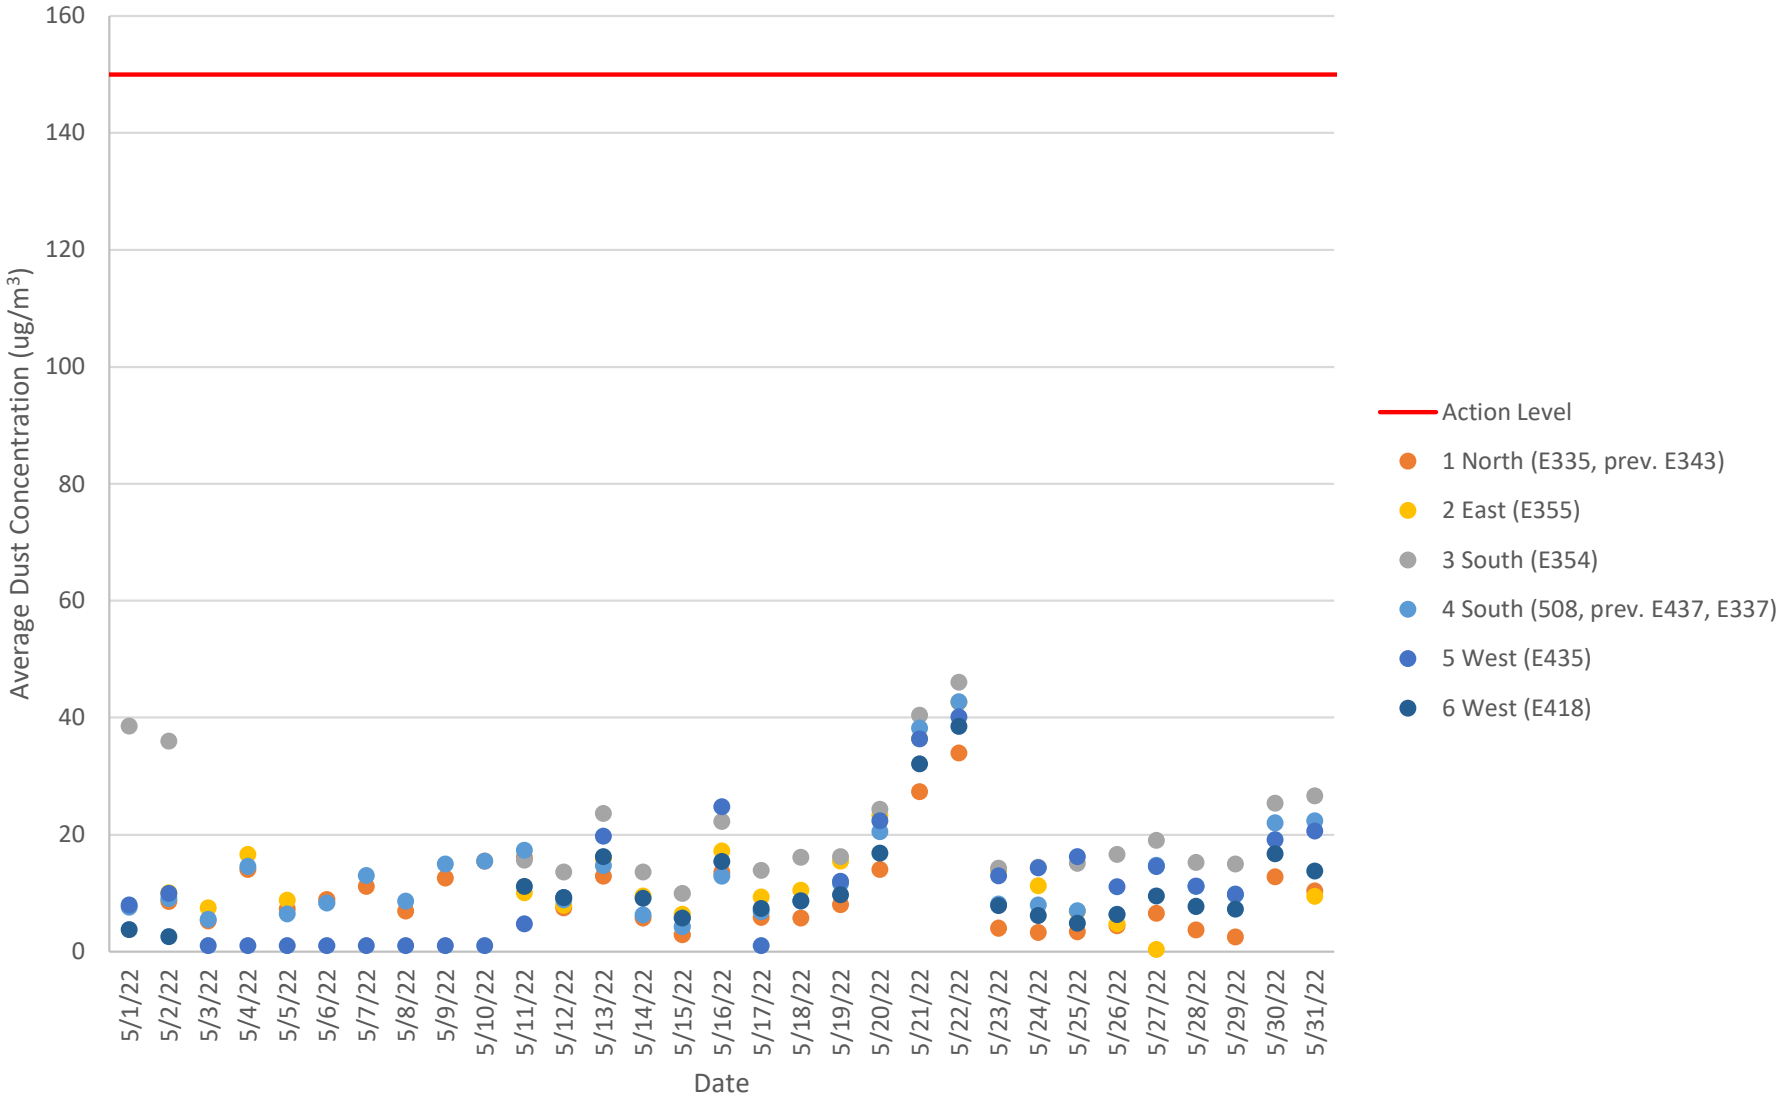
Dust Concentration 24-Hour Averages
May 1 - May 31, 2022
776 Summer Street
Boston, Massachusetts

Dust data was collected in accordance with the site perimeter DMP, and the results for May 2022 are included on Figure 3. As shown on the figure, there were no exceedances of the dust action level of 150 µg/m^3 for PM10 particulates based on a 24-hr average.
