## Monthly Dust Monitoring Report

L STREET STATION PROJECT  
*Boston, Massachusetts*

Prepared for HRP 776 Summer Street PropCo, LLC  
File No. 4867.03  
March 2023

## **L STREET STATION PROJECT**

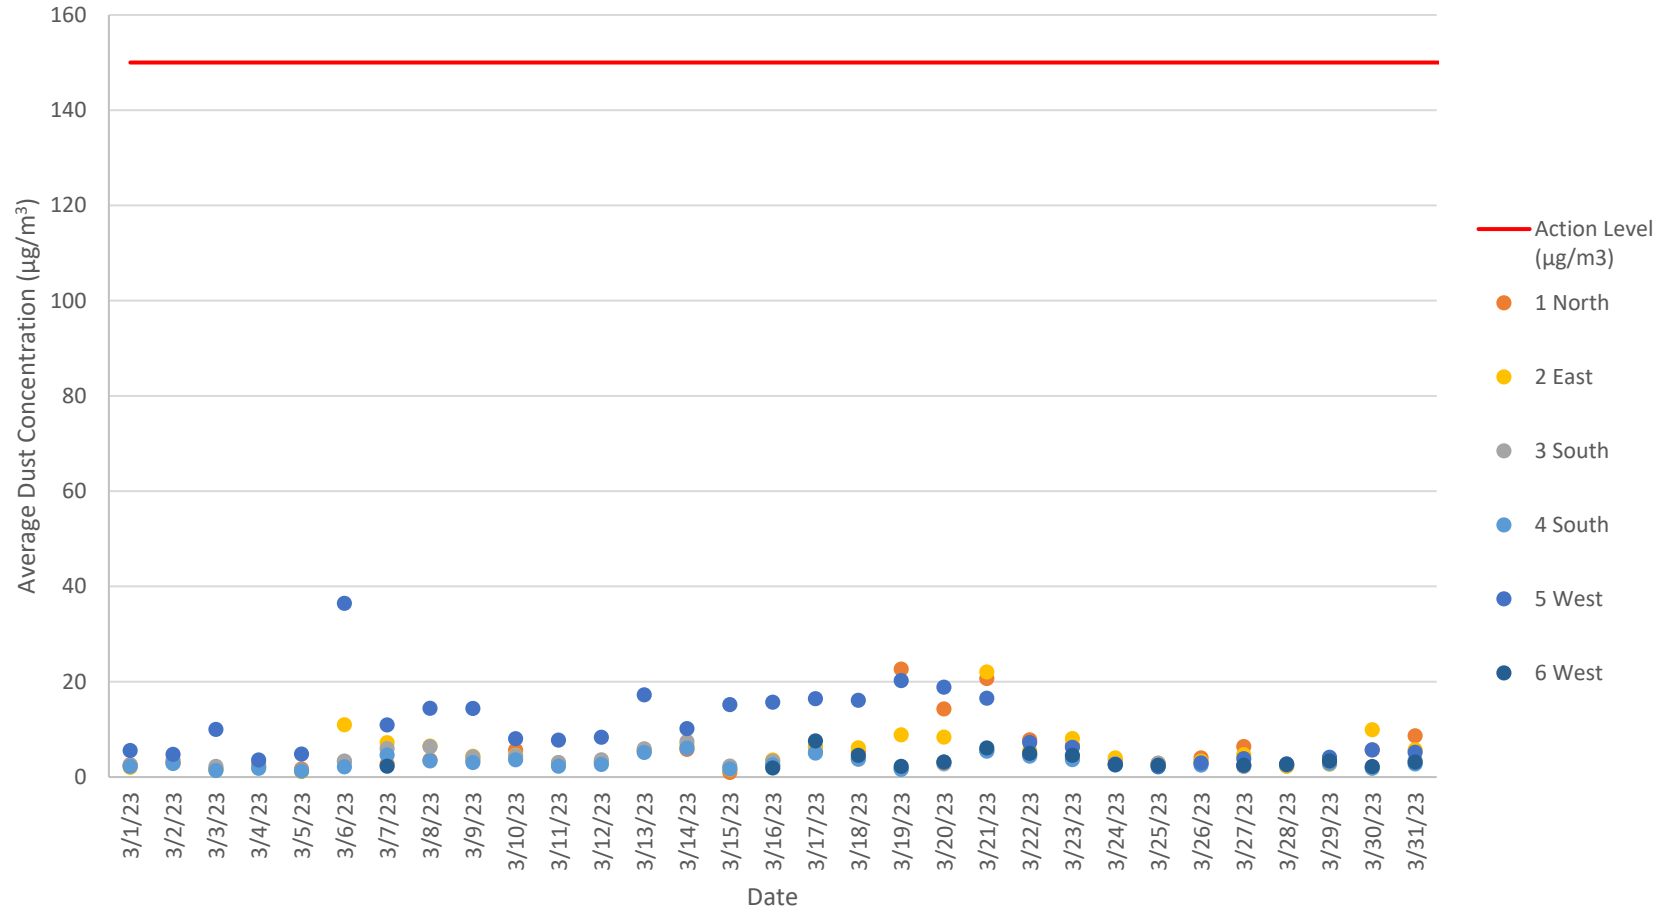
**Dust Concentration 24-hour Averages**  
**March 1 - March 31, 2023**  
 776 Summer Street  
 Boston, Massachusetts

Dust data was collected in accordance with the site perimeter DMP, and the results for March 2023 are included on Figure 3. As shown on the figure, there were no exceedances of the dust action level of 150 µg/m<sup>3</sup> for PM10 particulates based on a 24-hr average.

No corrective measures were required for dust mitigation in March 2023 because dust concentrations collected were well below the calculated Site-specific action level.
